Building Safety Inspection Report Form Amended 03/15/12

ELECTRICAL

Building / Structure address 1950 South Ocean Blvd., Laud.-By-The-Sea, FL 33062
 Legal description The Native Sun Resort
 Folio Number of Building /Structure _____
 Owner's name The Native Sun Resort
 Owner's mailing address 1950 South Ocean Blvd., Laud.-By-The-Sea, FL 33062
 Building Code Occupancy Classification In accordance with Building Code Edition
 Type of Construction In accordance with Building Code Edition
 Electrical Installation In accordance with National Electrical Code Edition
 Size (Square footage) 12,500 SF Foot Print
 Number of Stories 4

MINIMUM INSPECTION GUIDELINES FOR
BUILDING SAFETY INSPECTION
ELECTRICAL

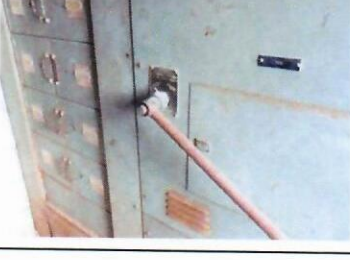
I. Electrical Service:
A. Size, Amperage, Voltage: 1600 Amps 250 volts
B. Phase: 3 Phase
C. Condition: Good Code Compliant (✓) Requires Repair ()
D. Comments: Need clean and paint rusted panels

<p>Main Panel 1600 AMPS 250 VOLTS 3 PHASE</p>

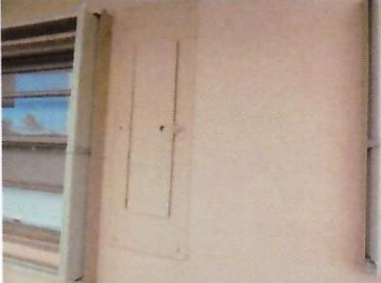
A photograph showing a white electrical panel mounted on a light-colored wall in a hallway. The panel has a single door and is positioned next to a window with blinds.		Hallway Units Electrical Panel

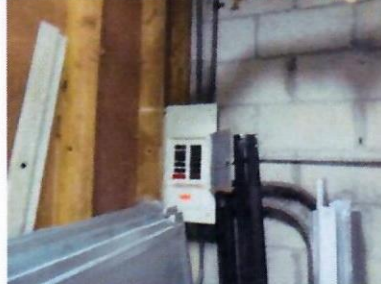
A photograph of a sub-panel mounted on a wall. The panel is white and has several electrical outlets. It is surrounded by other electrical components and pipes.		Sub Panel, need remove other part around panel

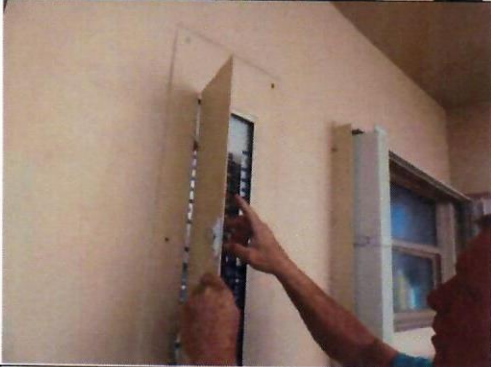
VII. Electrical Panels:
A. Location Hallways Code Compliant (✓) Requires Repair ()
B. Clearance Code Compliant (✓) Requires Repair ()
C. Identification Code Compliant () Requires Repair (X)
D. Comments: Electrical panels at hallway need to fix

Hallway Panel need to fix

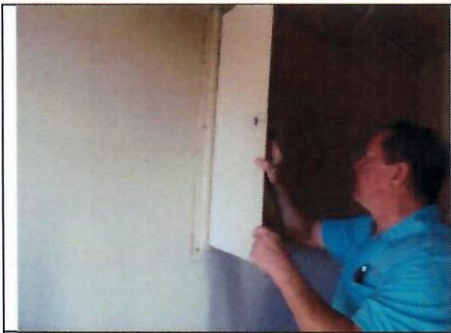
Hallway Panel need to fix

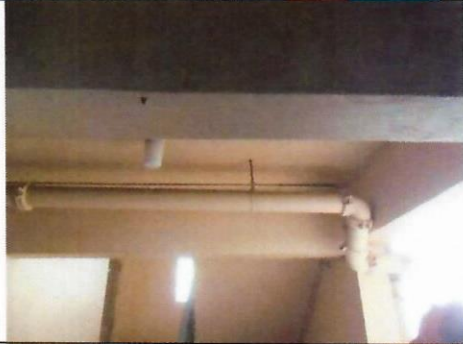
Need Exit sign at east hallway
